THE CHURCH AT KHIRBET DEIR SITUN

John CURTIS*

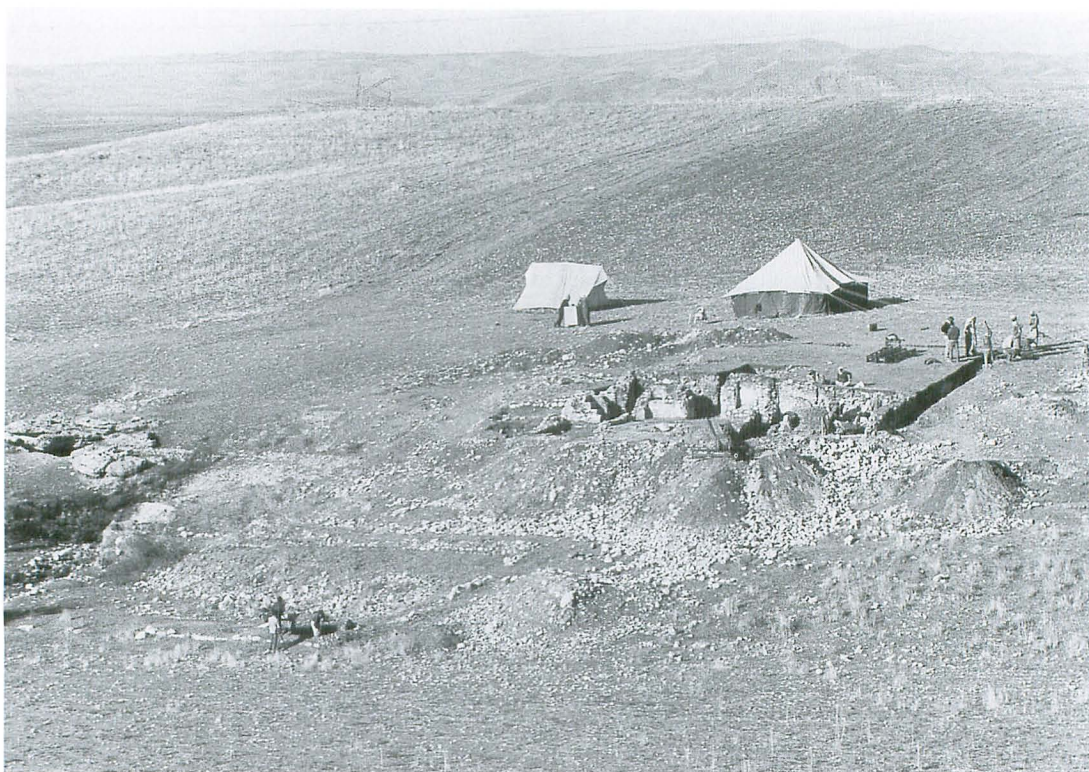
b Excavations at Khirbet Deir Situn, viewed from the west.

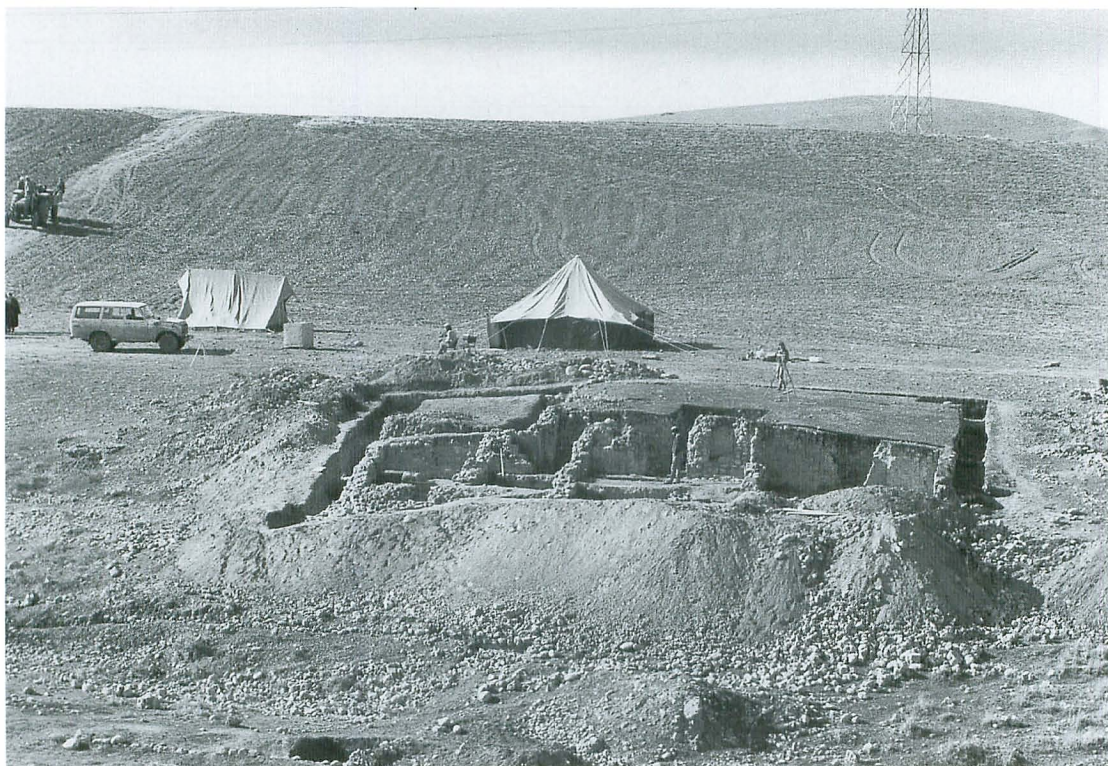
a The excavated building at Khirbet Deir Situn, viewed from the west.

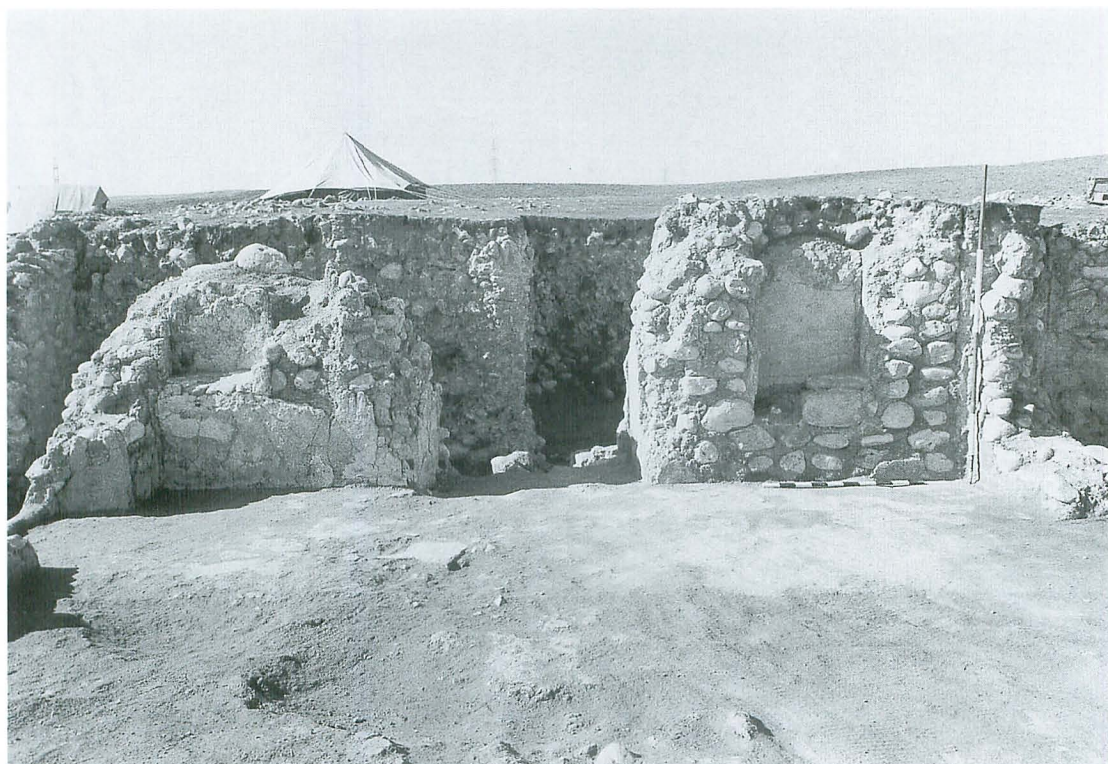
b The west side of the chancel at Khirbet Deir Situn showing the doorway through to the nave with niches on either side.

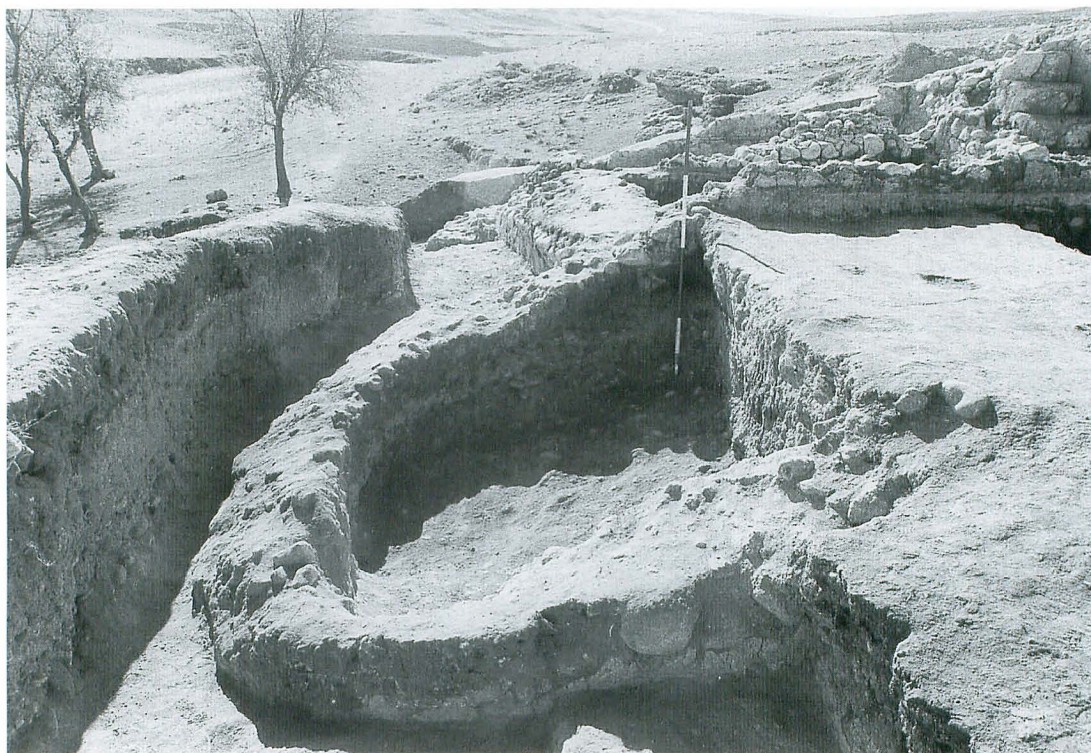
a The apse at the east end of the chancel at Khirbet Deir Situn.

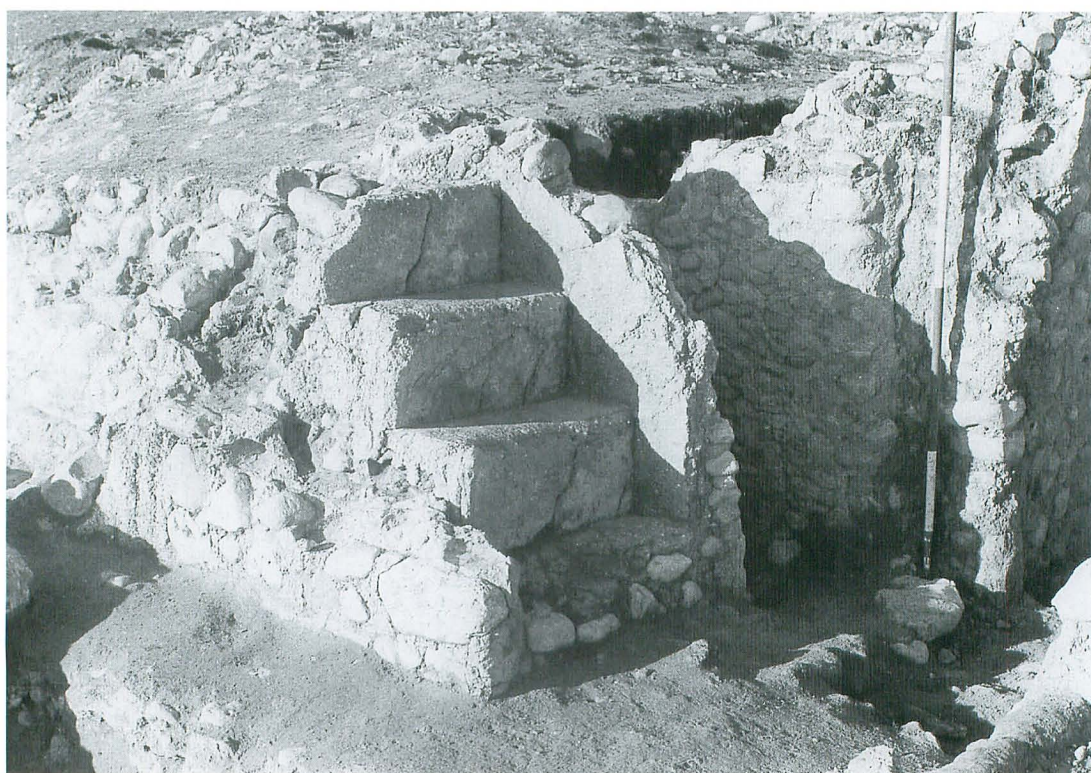
b The remains of the spiral staircase at Khirbet Deir Situn.
